Patient Safety Alert

AL09-06

November 20, 2008

MAXI MOVE with Lock & Load system (Combi Hanger) ID [080811AHE]

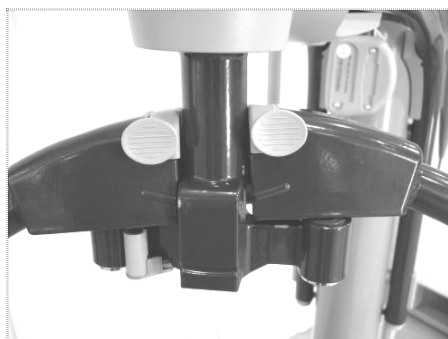
However, there is a remote possibility that, when pushed upwards, the hanger will be only partly detached, in which case a complete detachment may occur later, e.g. when a patient is being transferred. Such a detachment could result in a patient fall and there is a possibility the patient could sustain bumps, bruises, cuts, or more serious injuries, should a fall occur.

Partly Detached Hanger

- All MAXI MOVE patient lifters equipped with a Lock & Load Hanger, manufactured up to and including week 32 of 2006 (August 4th) are affected and will have to have the hanger attachment device (T-bars) replaced.

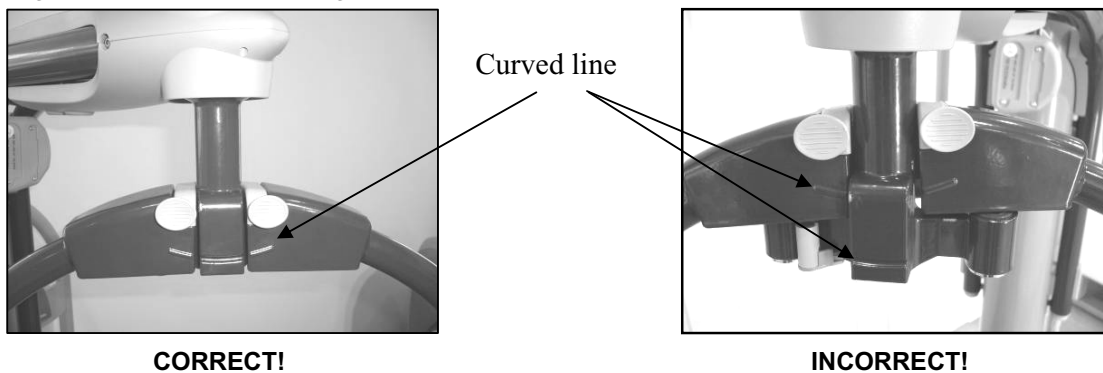
- Re-train caregivers not to lower the hanger bar onto rigid surfaces, thereby avoiding the possibility that the hanger will be dislodged.
- Re-train caregivers on how to ensure the hanger is properly attached to the T-bar before and during the initial phase of all lifting operations. This is easily done by confirming that the hanger's curved line is aligned with the corresponding line in the T-bar.

If these instructions are revisited, the device is safe to use as the above described partial dislocation is only possible after the hanger bar has been pushed upwards.

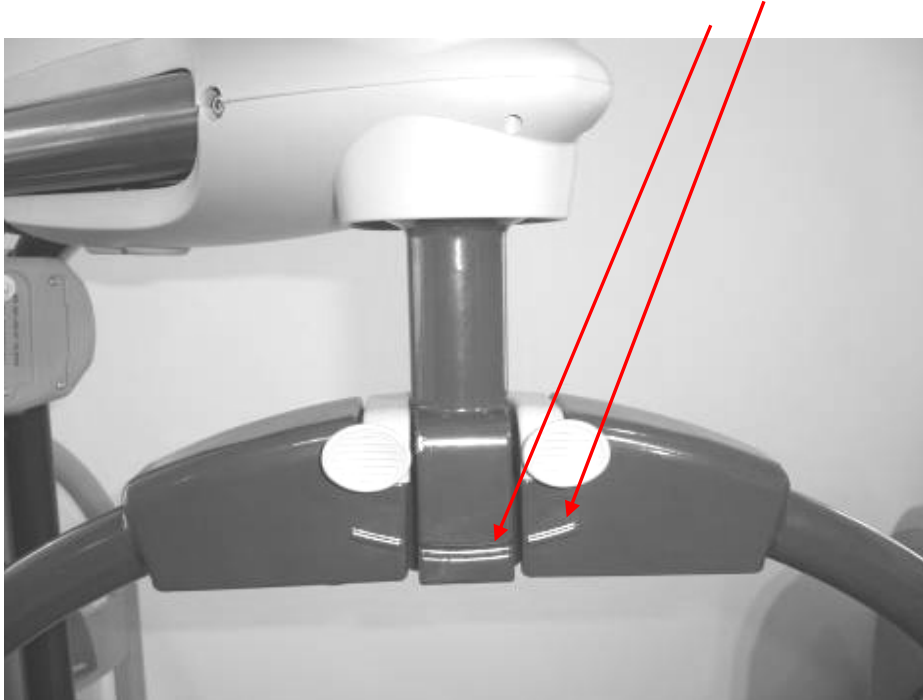
Correctly attached hanger

(Curves line up)

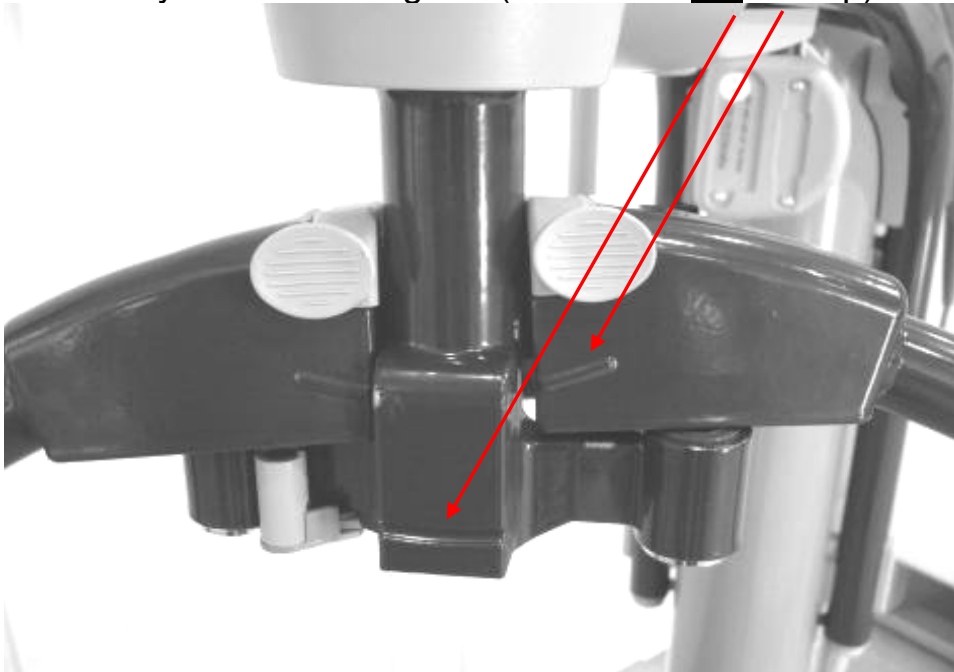
Incorrectly attached hanger

(Curves do not line up)
