Patient Safety Alert

AL09-23

Item: Philips IntelliVue G1/G5 Anesthesia Gas Modules:
Model Numbers M1013A and M1019A and
Dräger Apollo Anesthesia Machines and Multigas Monitor:
Model SCIO

TITLE:
FCO86201007A: M1013A/M1019A G1/G5 Gas Module – Too high sample flow

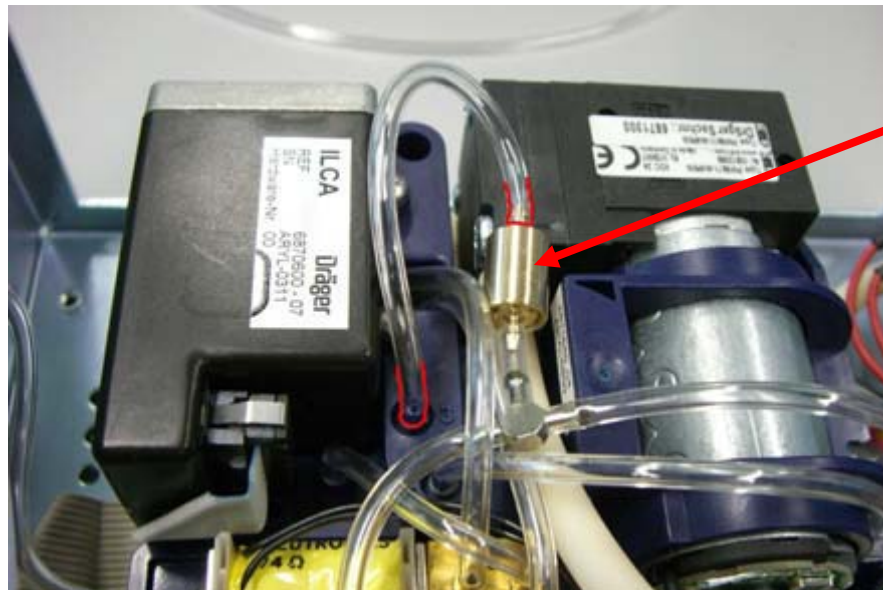
Reason: - Increased extraction rate of anesthetic gas metering
 - Frequent occurrence of 'Water trap / Scavenging line' message
 - Zeroing error of Pato O2 sensor with error code 6014
 - Pump error code 3705 (pressure drop too small)

Solution/Procedure: **1. Units under service contract:** Installation of a new flow restrictor
2. Units without service contract: Installation of new flow restrictor in case of repair
