Patient Safety Alert

AL06-06

Item: Injector connector relays on patient tables manufactured by Philips Medical, table models AD5 and AD6 used with the Integris, Integris Allura and Allura Xper x-ray systems.

Subject: User Notification, Injector Connector on AD5/6 Table, FCO 72200063

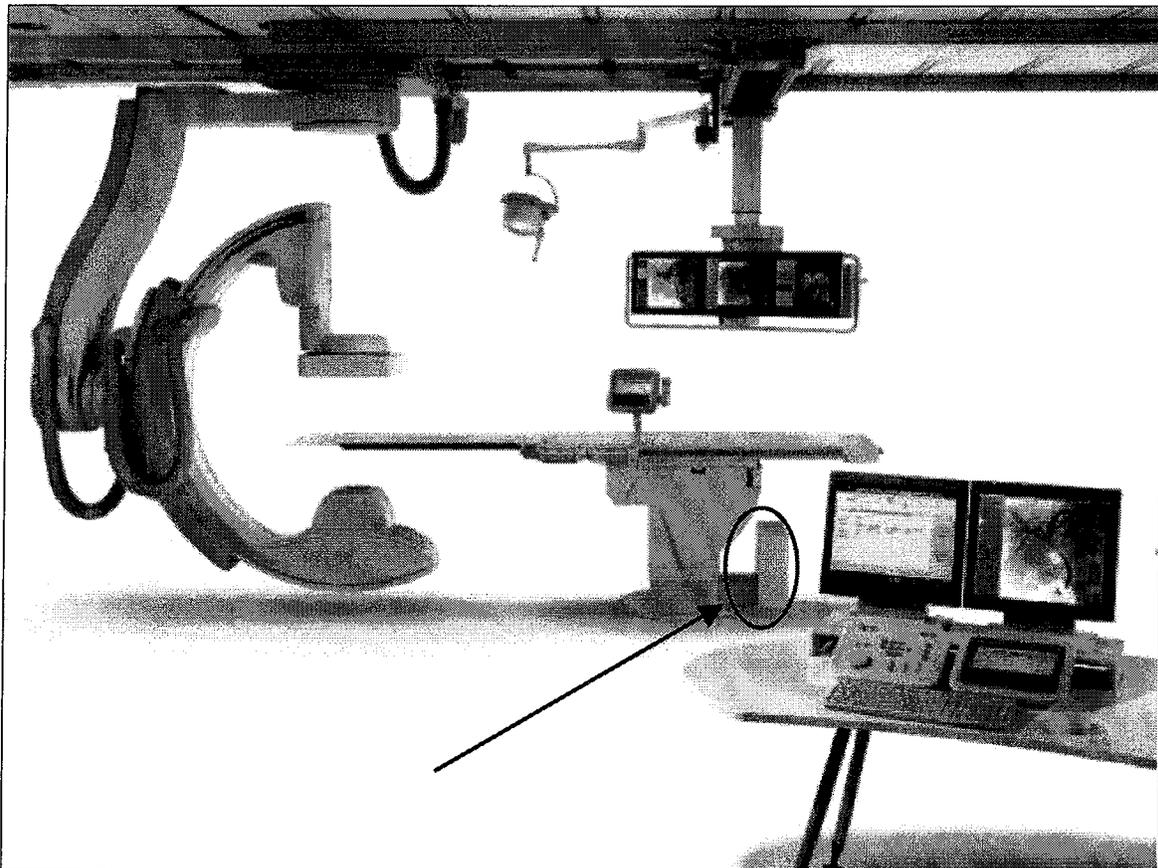
Exhibit 1: AD5 and AD6 Injector Plug Diagram

AD5 and/or AD6 Connection Boxes are located at backside of Patient Support (table), as shown by the red arrow and circle. The actual connector in question (provided for use with injectors) is located on the Nurse's side of the Patient Support. See other pictures below for detail.

Since the injector connector plug is normally exposed when not in use, we advise you to cover it with a nonconductive material (such as a plastic cap, for example) when unplugged, or if not utilized. This will minimize the risk of accidental contact, until Philips can provide a permanent modification. Please instruct all personnel to be cautious when (un) plugging the injector into the table base, as well as when cleaning (avoid wiping area around connector unless well covered). Additional diagrams are supplied on Exhibit 1 and are attached with this letter to help you identify the location of the connector plug in question.

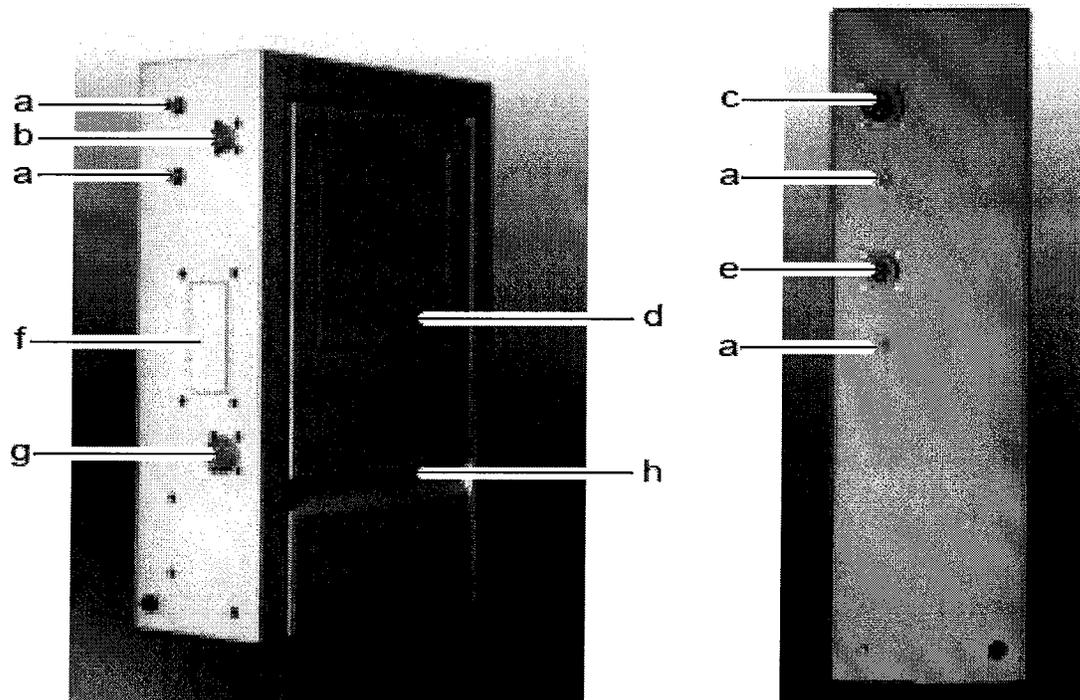
Connection box (at back of patient support)

The connection box shown here is for an **AD5** table (Patient Support). The connector in question is noted as “c”.

Item	Connections
a	Earth (ground).
b	X-ray hand switch.
c	Injector.
d	Prepared for local mains connection.

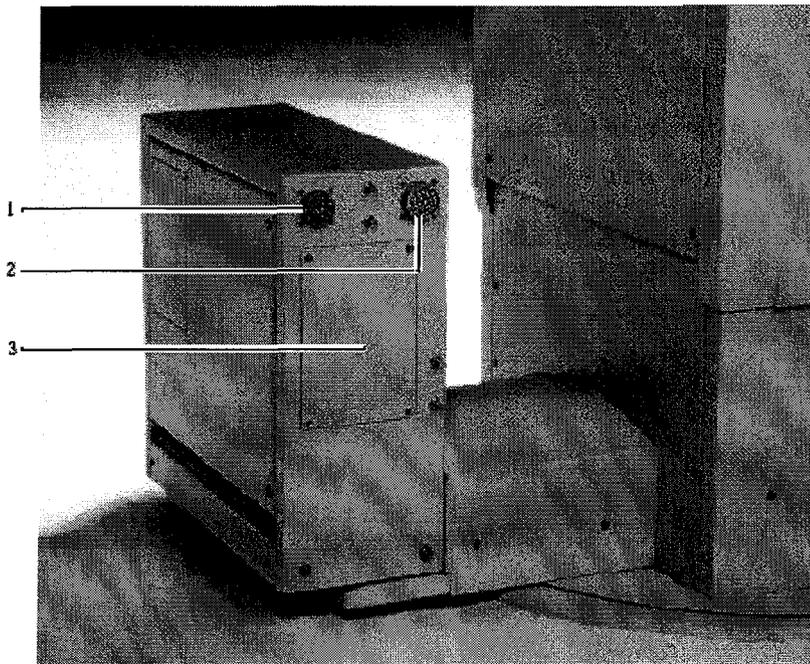
Figure 4.106 Table base connection box

The connection box shown here is for an **AD6** table (Patient Support). The connector in question is noted as "2".

The table base connection box is located under the table top at the rear of the table base. The connection box allows to connect different types of additional equipment to the system.

- [1] 23-pin Burndy connector
Connector for external ECG and Physio equipment.
- [2] 28-pin Burndy connector
Connector for external pedestal injector.
- [3] Connector instead of cover plate (not physically shown)
Instead of the cover plate, a connector can be located here that allows to connect various types of rack-mounted injectors.
